1 电感失效分析——返修引入超过器件规格的热应力

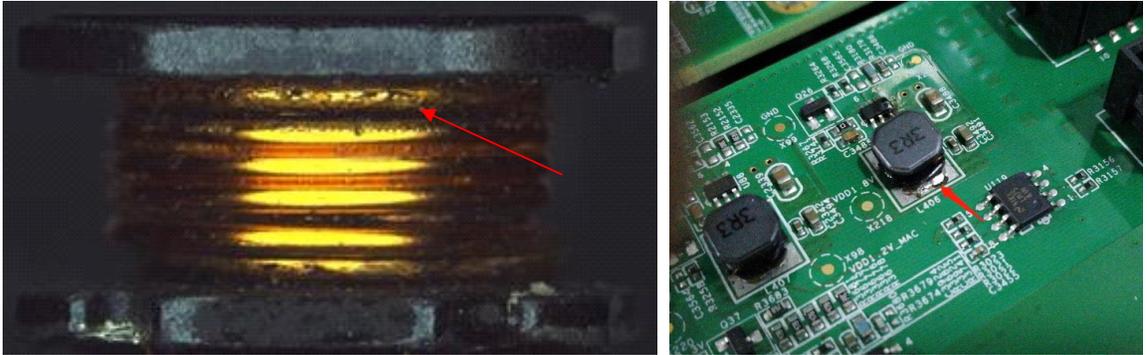
生产出现 12 例 3R3 电感异常导致电源芯片烧毁问题，其中已分析的失效样品失效现象是靠近印字面的漆包线漆膜受热融化，且在跟踪分析时发现个别板子电感被返修过，详见下图。

1) 制定电感返修方案：返修电感热风枪拆下后更换新的电感，更换新电感需预热并管控烙铁温度；电感供应商推荐的返修方案：

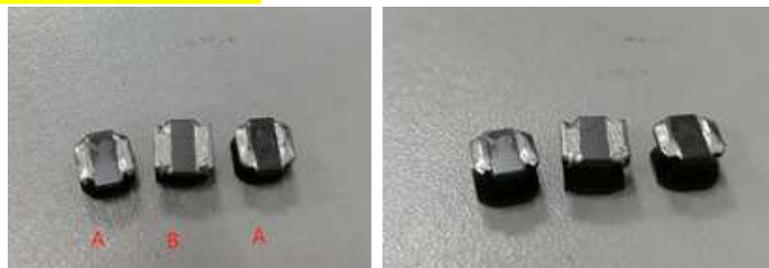
经调查，该 3R3 电感在生产制造中经常出现位偏问题，通过观察该料焊盘发现其共面性较差，因此需要选用共面性好的物料替代以降低电感位偏问题。

结论：B 料焊盘共面性要优于 A 料，具体对比见下图。

2) 解决电感位偏问题，降低返修率：

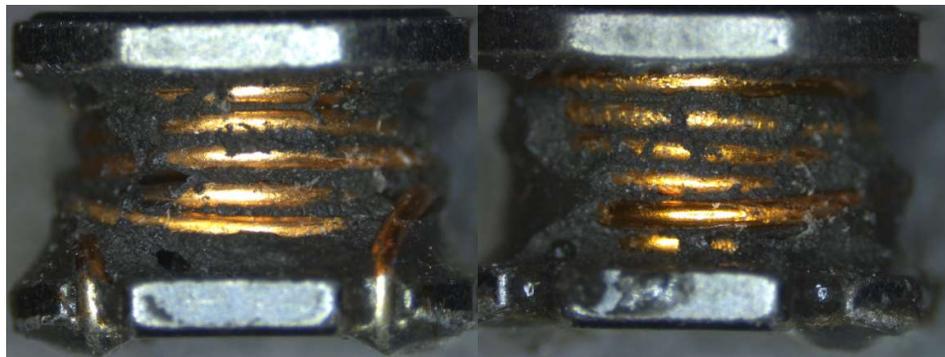
异常热应力导致漆膜融化图片：
